Manhole Inspection Summary

Manhole # S21K__029MH

Insp Date: **4/3/08 1:36 PM**

Location Address: **344 s fulton av**

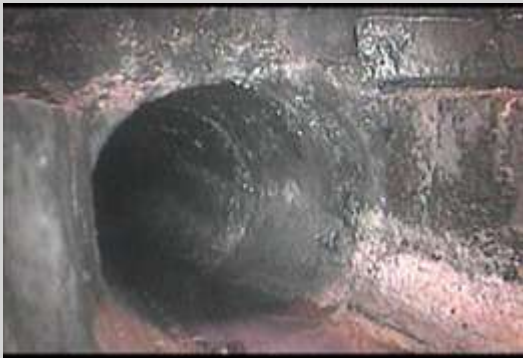
12 O'Clock Outflow

Pipe Height: **8.4** (in.) Rod and Bar (Angled)
Pipe Material: **Clay** ☐ Pipe Lined
Invert Depth: **10.93** (ft.) Flow Characteristics: **Slow**
Deposits: ☒ None ☐ Mud ☐ Sludge ☐ Debris ☐ Grease
Silt Depth: **0** (in.) Deposits Extent:
Infiltration: **None** Pipe Seal Cond: **Sound**

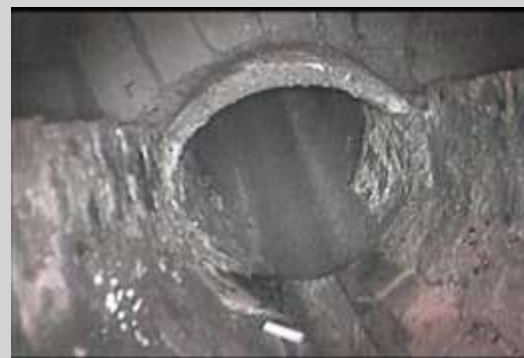
Pipe Height: **8.4** (in.) Rod and Bar (Angled)
Pipe Material: **Clay** ☐ Pipe Lined
Invert Depth: **8.49** (ft.) Flow Characteristics: **Fast**
Deposits: ☐ None ☐ Mud ☐ Sludge ☐ Debris ☒ Grease
Silt Depth: **1** (in.) Deposits Extent: **Light**
Infiltration: **None** Pipe Seal Cond: **Sound**

Drop: **Outside** Rod and Bar
Angled: **Yes** Reading: **9.73** (ft.)
Inv Depth: **10.73** (ft.)
Drop Condition: **Open**
